# BEHAVIOUR OF SHORELINE AND COASTAL STRUCTURES AT ELSUKHNA PORT, EGYPT

Gamal H. Elsaeed

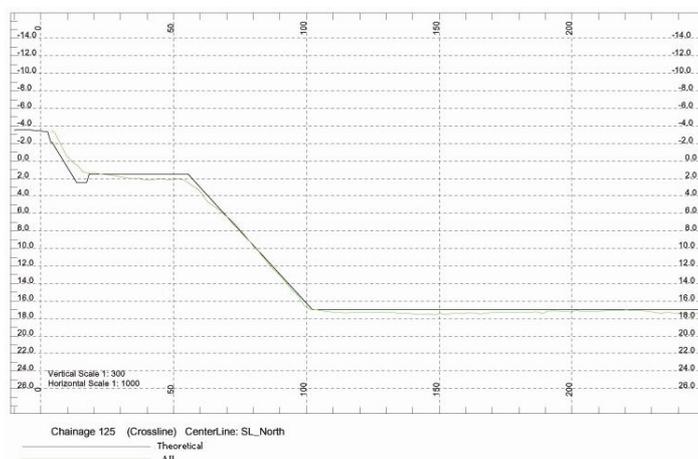
**Fig. 2.** Cross section of the turning circle for the North side

- Removal of high spots close to the Western quay wall between stations 0 to 220 to the design level of -17.0 CD.
- Dredging on the south berm turning circle of 30m width from St 1100 to St 1700 to the design level of -1.5 CD.
- Dredging on the berm for south slope protection from St 1500 to St 1700 to the design approved levels of -1.5 CD.
- Dredging on the berm for north slope protection from St 1500 to St 1700 to the design approved levels of -1.5 CD.
- Re-grading the north and south beach area from St 1700 to St 2100.
- Dredging areas up drift North and South Breakwater.

The combined results of the surveys are presented in Figures 2-3 show sample cross sections for the turning circle including the adjacent slope protection and Figures 4-5 show sample cross profiles for the shore access channel showing the adjacent breakwater.

Small differences are discernible between the different surveys when plotted on the cross profiles even though no correction works have been performed at the location. This may be explained by the processing of the echo-sounding data into cross profiles that requires interpolation to be performed between adjacent measured points in locations of rapid change of elevation, such as a dredged slope. This can lead to differences developing on the survey plot despite there being no change in the seabed profile.

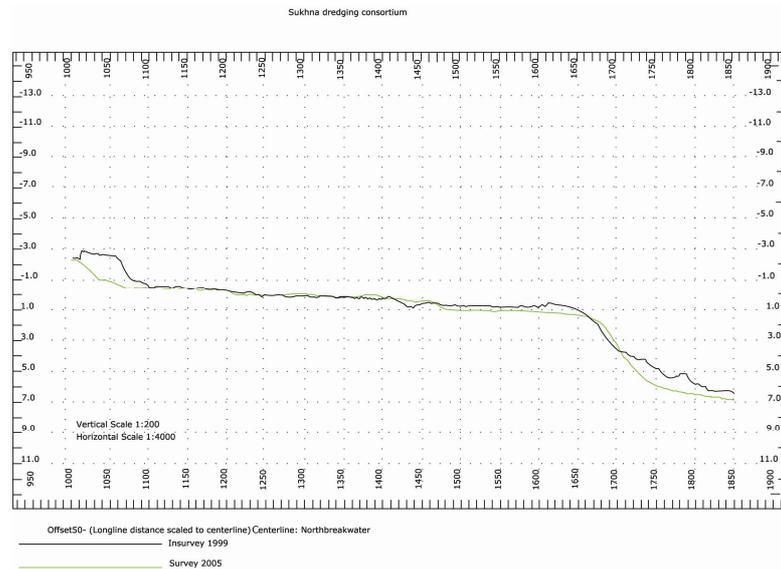
**Fig. 6.** Cross profile for the beach outside the North Breakwater

Bathy charts and cross profiles of 0m to 125m from both the breakwaters were produced. See Figures 6-7.

Sample results of the surveys are presented in Figures 6-7, showing the comparison between the initial and final surveys.

Difference of seabed levels between the original survey in 1999, before the port was initially built, and the survey of February/March 2005 (between -2 and -6 CD) were removed up drift the north and south breakwaters. The dredged volume of the areas mentioned above is 2.99m<sup>3</sup>.

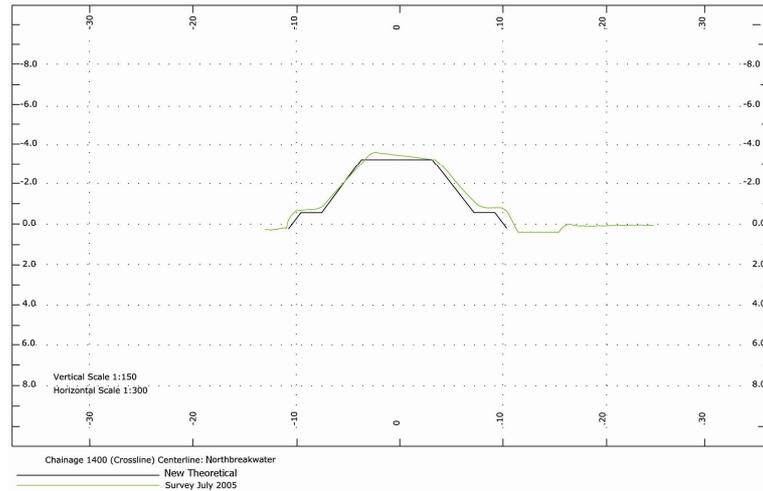
**Fig. 8.** Cross profile for the North Breakwater

In February and March 2005, the rocks were generally found to be in a good condition, but some minor defects were detected in the toe and armour layers of both breakwaters.

The results of these rockworks and various surveys are represented in Figures 8-9.

Additional rocks were placed at all locations of both the breakwaters where defects were detected.
