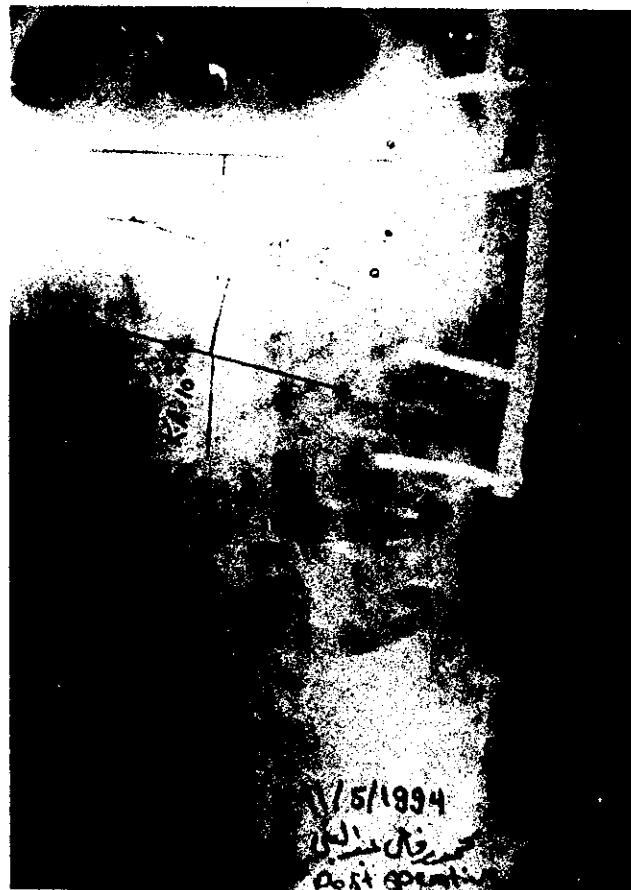
Fig. (43) A and B: Note the broken screws and the unmoulded construct.

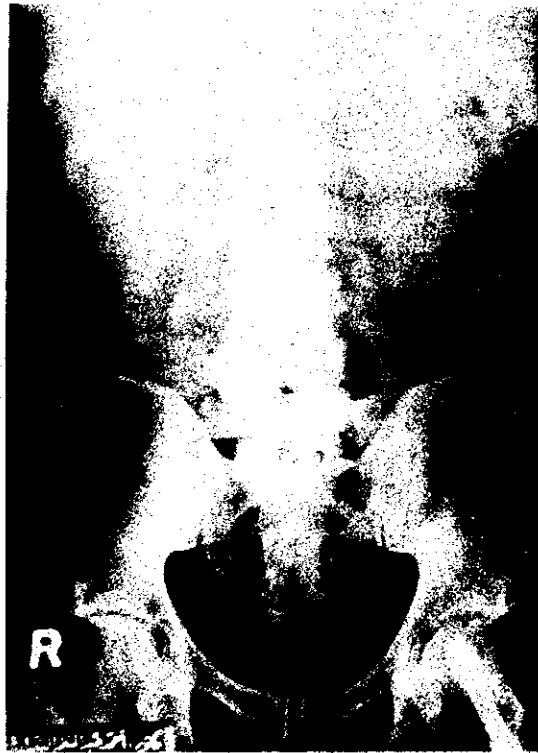
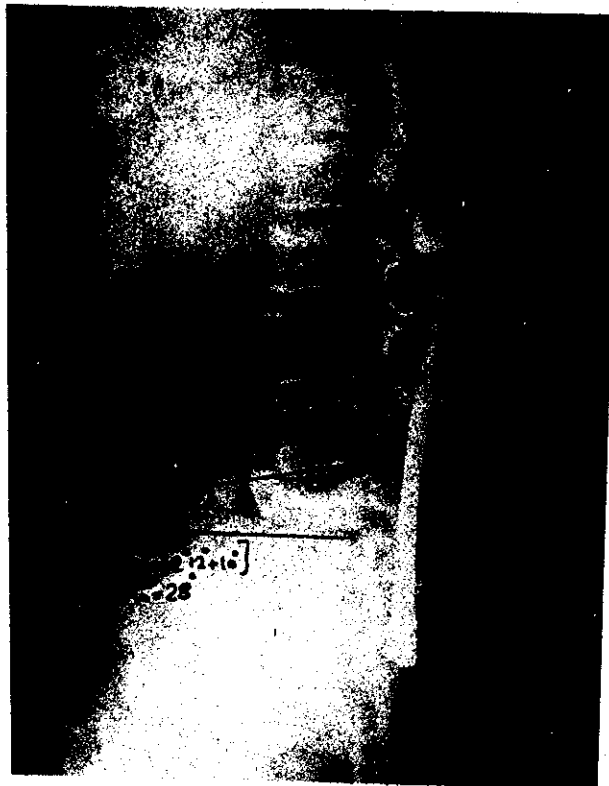
Fig. (44) A and B: Note the collapse of L4 even with the use of distraction rods.

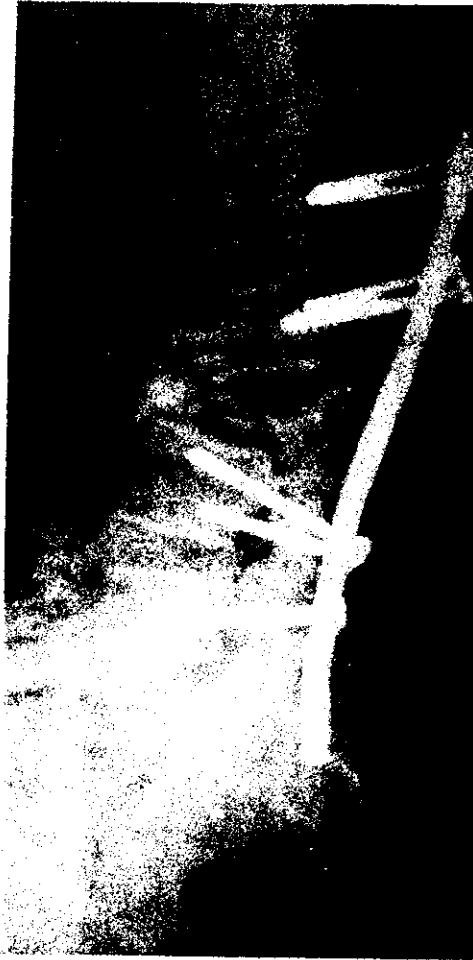
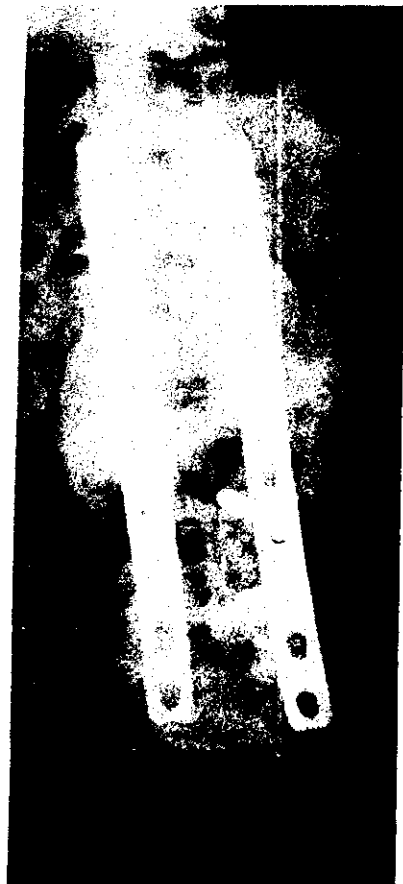
Fig. (53) A and B: An example of screws malposition.
