Results

This study was conducted on 20 patients collected from Qalubia/ Egypt.

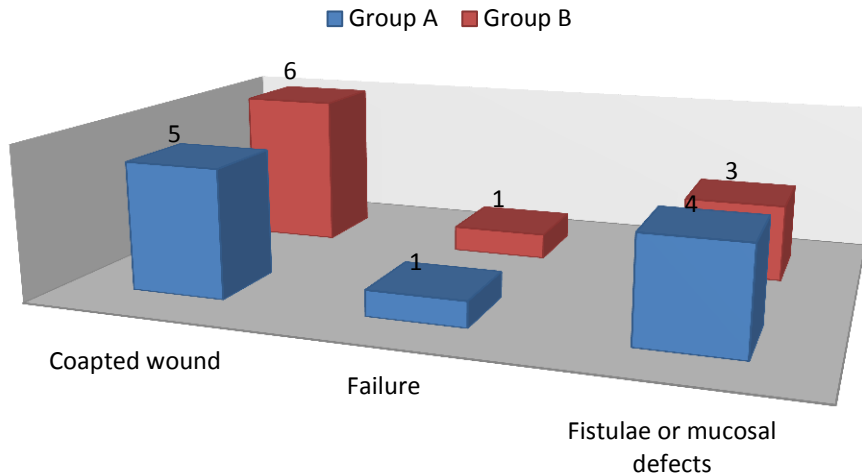
Chart 3

Number of patients according to healing results after one week

During the first week one patient showed total failure of the operation with re-clefting , 4 patients showed fistulae formation at the anterior part of the wound and 5 patients showed no fistulae nor failure with a coapted edges till the end of the first week (chart 3).

During the first week one female patient showed total failure after being subjected to accidental trauma to the wound in the 4th day postoperatively due to introduction of a hard object in the mouth leading to loosening of the middle part of the wound stitches Fig(21). 3 patients in the 5th day postoperatively showed exposure of the anterior part of the oral mucosa wound exposing the bioglass disc, although a whitish membrane was seen covering the exposed part. The other 6 patients showed no fistulae nor failure with good coapted wound (chart 3).

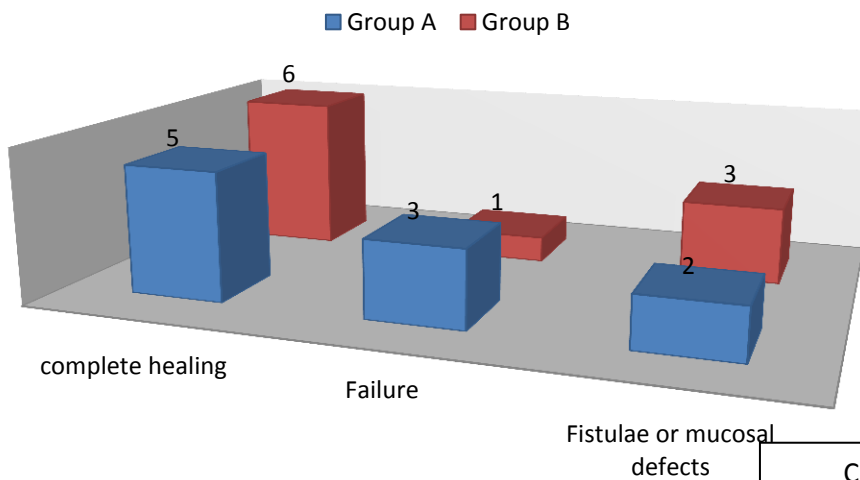
Chart 4

Number of patients according to healing results after two weeks

In the second week 2 of the patients with fistulae showed widening of the fistulae followed by total failure with re-clefting, while the other 2 showed permanent fistulae (chart 4).

During the second week the patients with exposed bioglass disc showed creeping of the mucosa over the bioglass disc decreasing the exposed diameter , by the end of the second week the exposed parts were very small in size nearly third of its starting size. Patients with coapted wounds were completely healed by the end of the second week (chart 4).

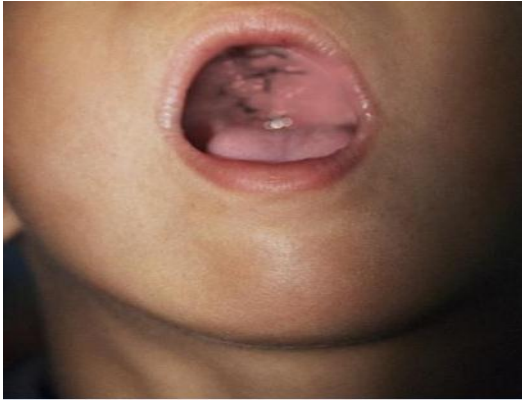
Fig (17):A patient from group A after one week with good coapted edges of the wound

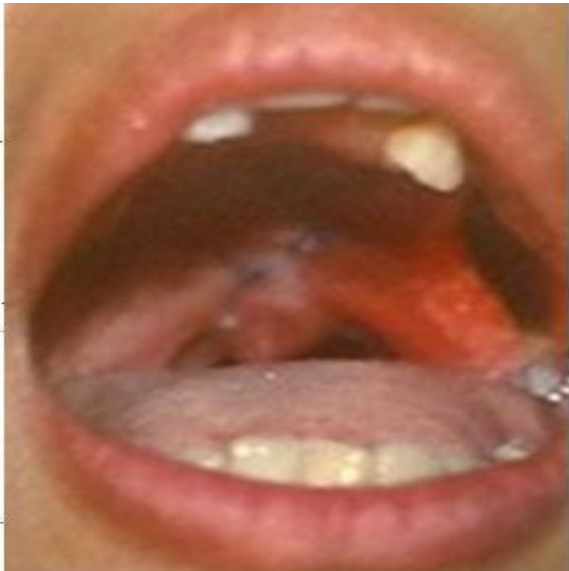
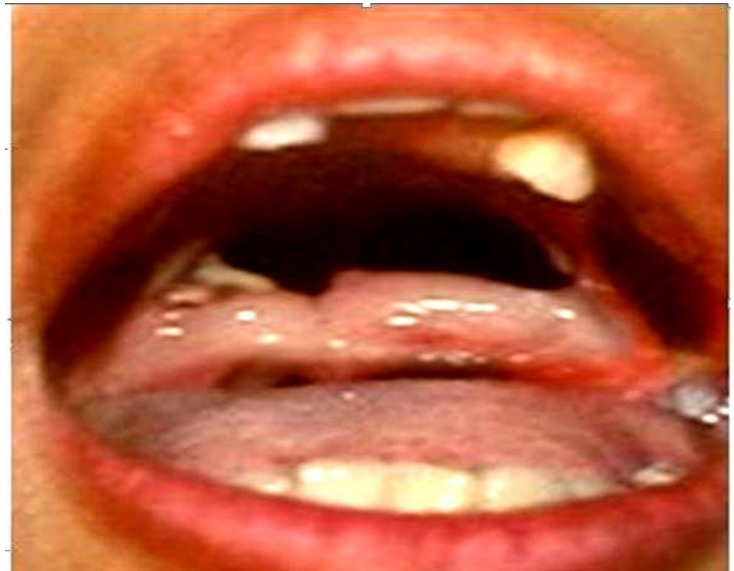
Fig (18):A patient from group A showing fistulization and failure after one week post operative

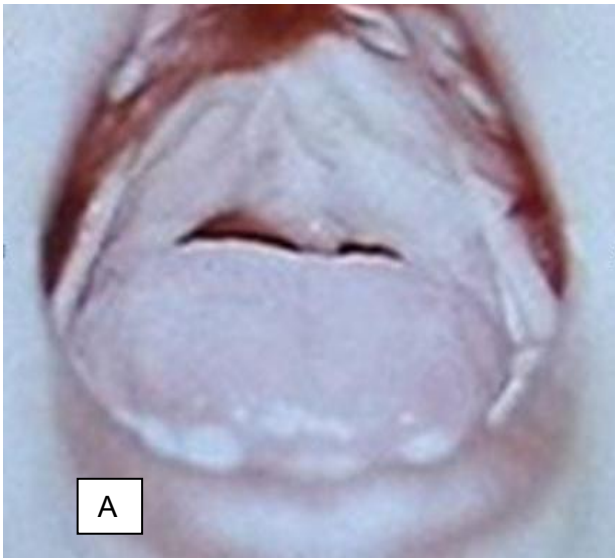
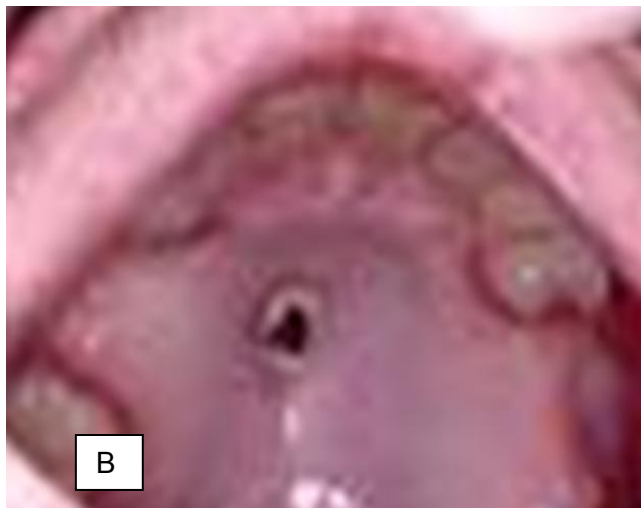
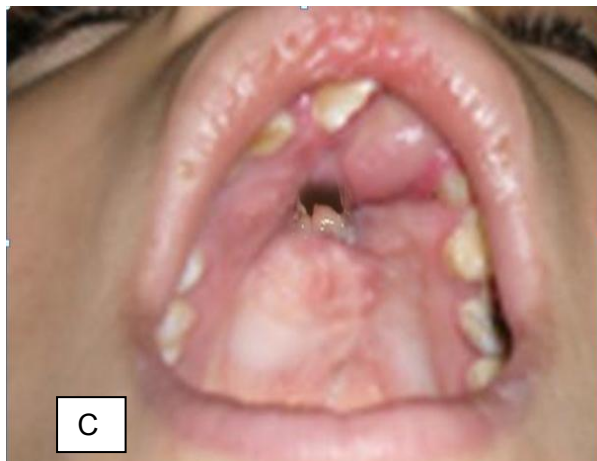
Fig(19): (A) Patient from group A with complete healing after 2 weeks from the operation, (B& C) 2 patients from group A with permanent fistulae after 2 weeks.

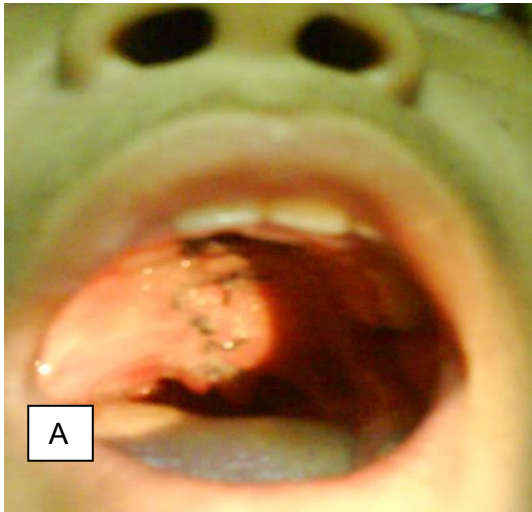
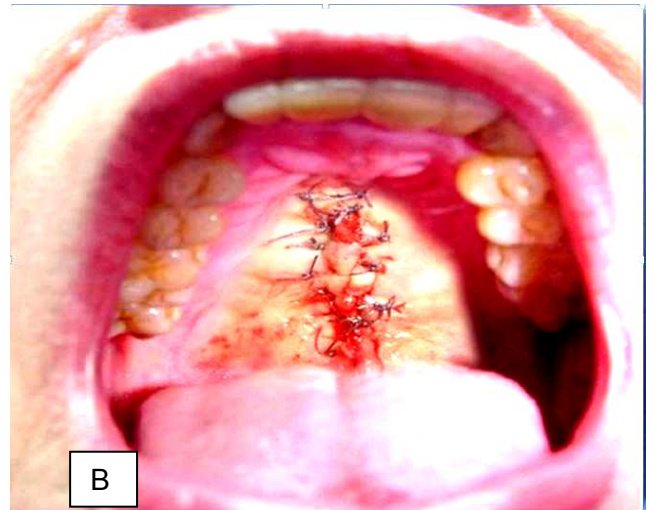
Fig (20):A & B 2 patients from group B after one week with good coapted edges of the wound.

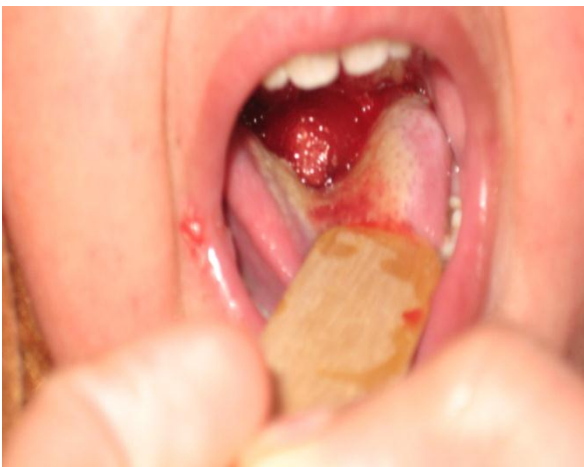
Fig (21):A patient from group B after trauma to the wound 4 days post operative.

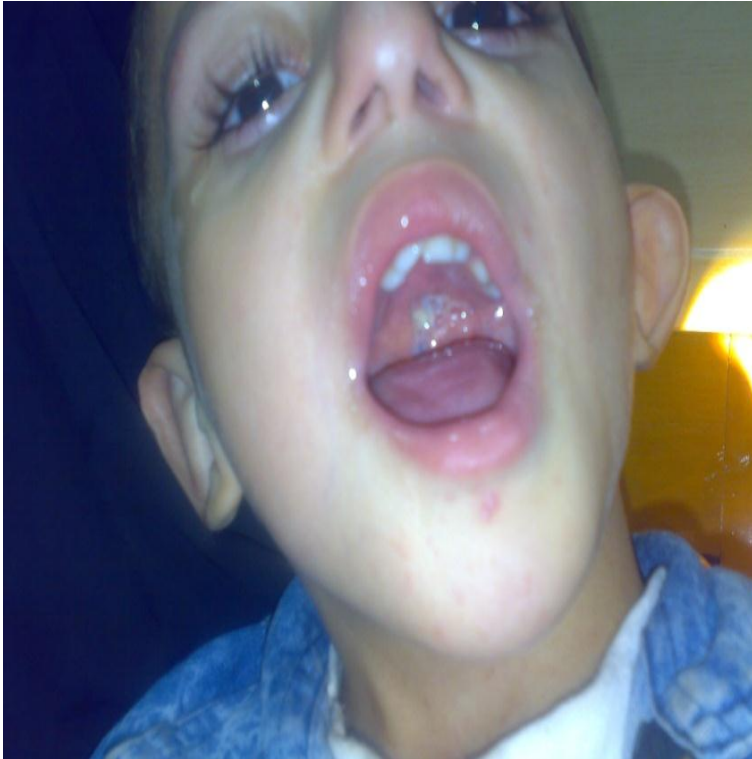
Fig (22):A patient from group B showing oral mucosal defect and exposure of the bioglass disc.

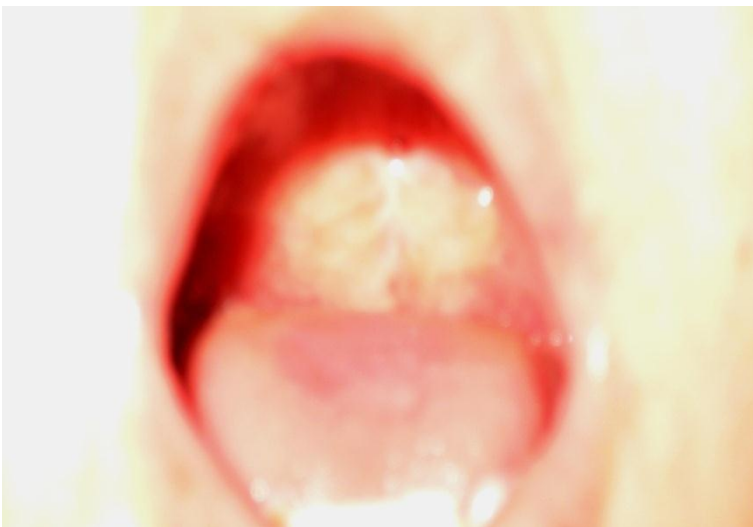
Fig(23): A Patient from group B showing complete healing after 2 weeks .

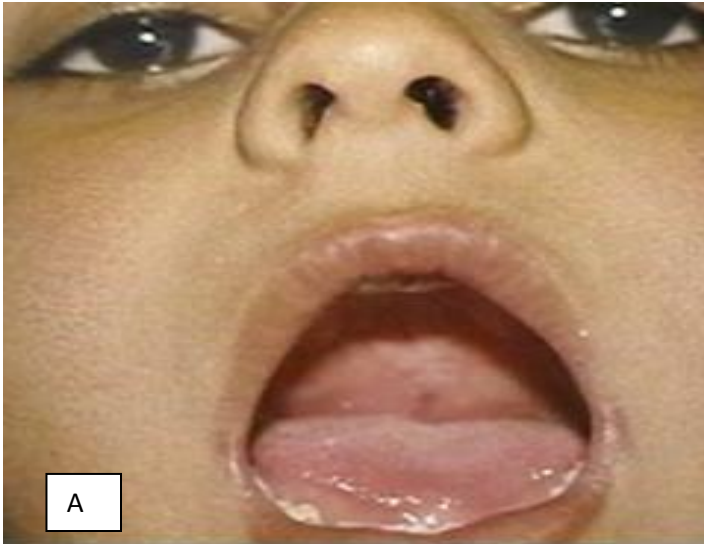
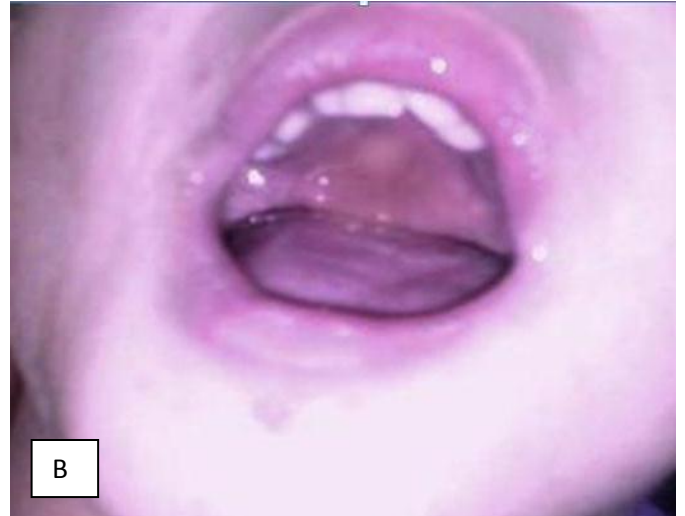
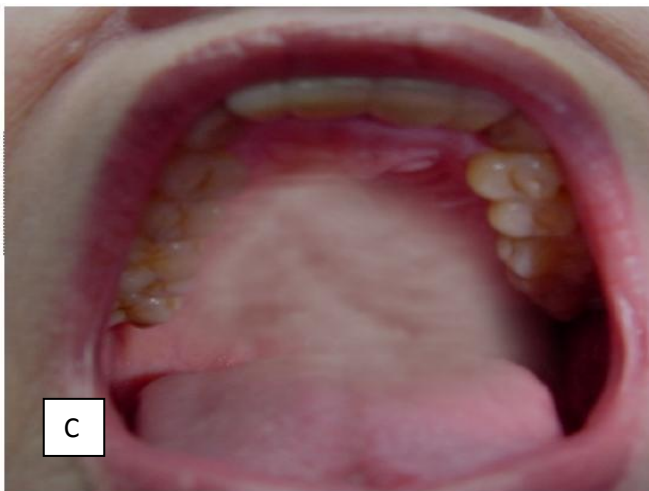
Fig (24): (A) & (B) Completely healed palate after oral mucosal defects , (C) completely healed palate with no previous defects three weeks from the operation.

By the end of the third week the 3 patients with exposed oral mucosa were completely healed with no signs of the fistulae apparent.

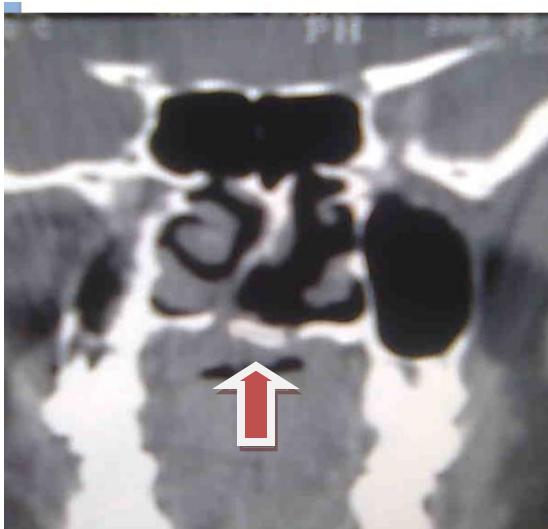
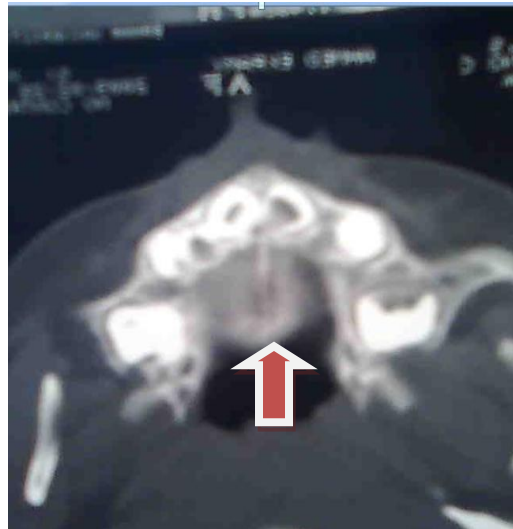
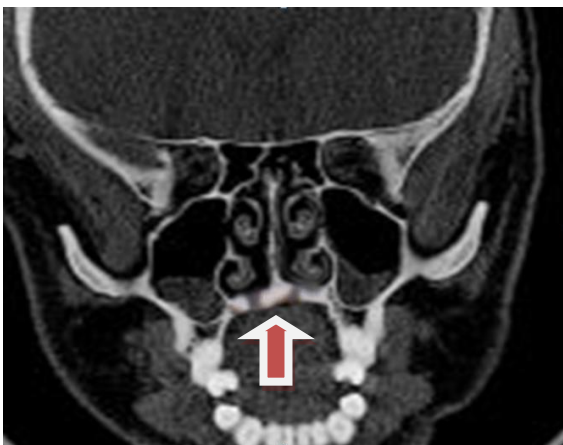
The bioglass disc was well distinguished in the palate by a soft tissue space between it and the bony part of the palate and gum from both sides (fig25).

Fig (25)C.T. of patients from group B after one week.

After one week from the operations done for group B, CT of the palate coronal and axial views were done to all patients with no failure (9 patients) i.e. patients with coapted wounds (6 patients) and patients with fistulae(3 patients).

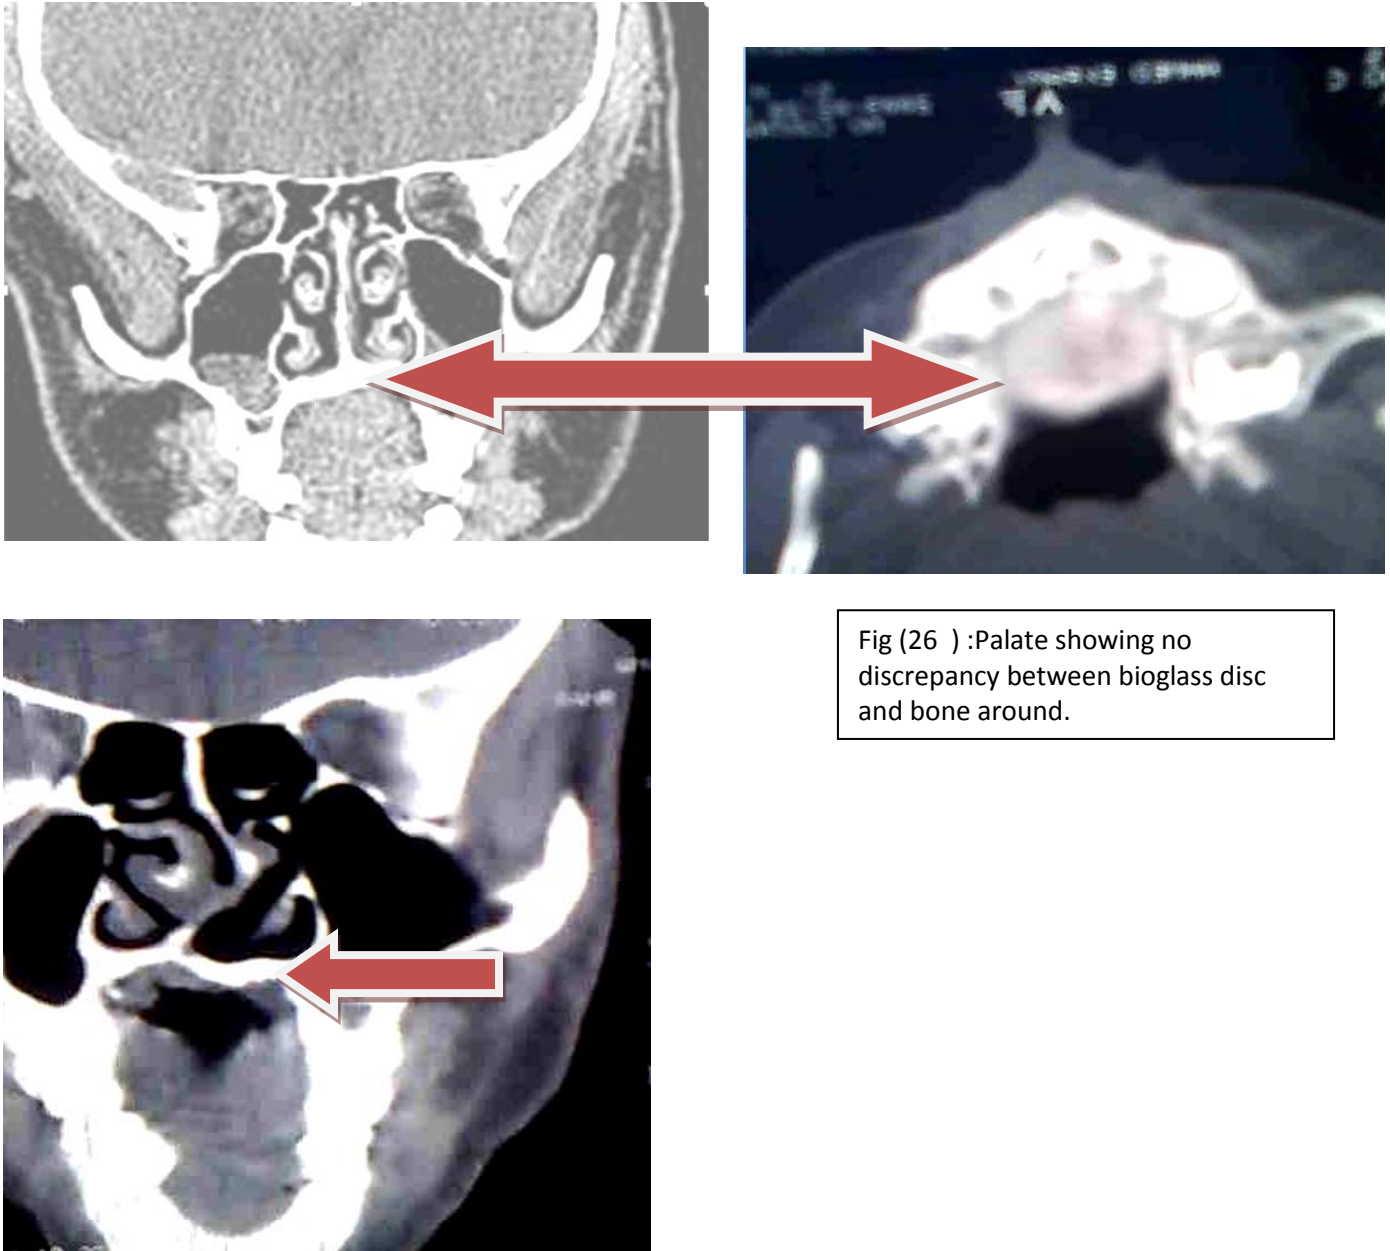
After six months CTs of the palate coronal and axial views were done for the same 9 patients from group B. All CTs showed no discrepancy between the bioglass discs and the bony palate and gums all around with complete bone formation (fig26).

Fig (26) :Palate showing no discrepancy between bioglass disc and bone around.
